# CSMA

## CASE STUDY ONE

### Analysis of a White Residue on a Circuit Board Connector

## Investigation of Corrosion Regions on Printed Circuit Boards (PCBs)

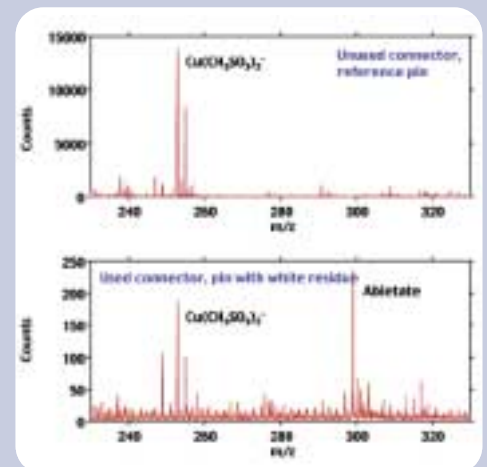
XPS showed that the levels of metallic species on the bad pins were quite low compared to the good pins. Concomitantly, the high carbon levels on the bad pins suggested an organic cause for the contamination. Examination of the carbon functionality by high resolution analysis showed that aromatic-type species were present on the contaminated surface.

In agreement with XPS, ToF-SIMS analysis showed that the good pins presented a more metallic surface whereas the surface chemistry of the bad pins were dominated by organic species. In particular, aromatic hydrocarbon and carboxylate (abietate) signals were detected on these contaminated surfaces. Research into the composition of the solder flux indicated that it was based on a rosin containing mainly a mixture of carboxylic acids of the abietic type (see ToF-SIMS spectra right). This strongly suggested that the white contamination corresponded to solder flux residue where, in view of the sample's thermal history, the aromatic hydrocarbon reflected a partial degradation product of the original component based on a rosin.

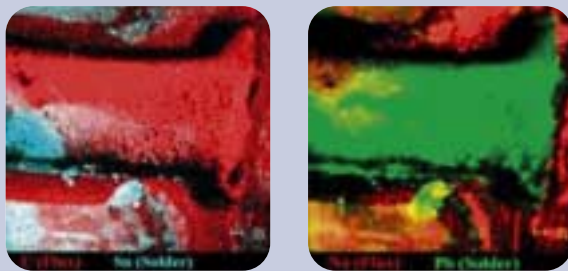
*OVERLAY OF SIMS IMAGES*

Combined XPS and SIMS analyses were carried out on a corrosion area between the SMT legs. These showed the presence of a complex mixture of inorganic ionic salts, organic residues and elements such as sodium, calcium, etc. The ionic salts included copper chloride, tin fluoride, lead fluoride, calcium fluoride and also oxy-halide species of tin and lead. The organic species were suspected to correspond to flux residues. The lateral distribution of selected species in a space between SMT legs are shown in the SIMS images below.

The presence of significant levels of elements such as sodium, calcium, fluorine, chlorine, tin and lead in the space between the SMT legs remaining after board production were believed to provide a basis for chemical processes resulting in the formation of the corrosion products described above. With the presence of water (acting as an electrolyte) from high humidity levels and heat (either from ambient conditions or generated in circuitry), the corrosion process may have proceeded through different ways such as redox reactions, galvanic processes, electrolysis via applied e.m.f between IC contacts, atmospheric oxidation, ionic salt formation or ion transport. The detection of copper in the corrosion product suggested ion transport ( $\text{Cu}^{2+}$ ) from the IC contacts or an underlying PCB track.
