TOTAL SOLUTIONS FOR THE GLASS INDUSTRY

INVESTIGATION OF MULTIPLE DEFECTS ON A COATED OPTICAL FILTER GLASS

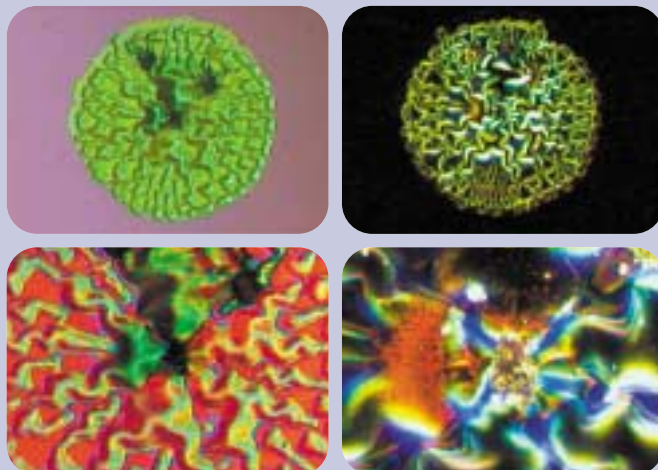
Initial investigation of the defects by optical microscopy (see right) showed the following features :-

- All defects are circular with a particulate-like feature in the centre $\sim 1 - 5\mu\text{m}$ in size.
- Topographic information indicates that the layer structure has buckled leaving fault lines that appear to radiate from the centre of each defect.

Optical Microscopy images of a defect - field of view is $400\mu\text{m}$ (top left and right), $200\mu\text{m}$ (bottom left) and $100\mu\text{m}$ (bottom right).

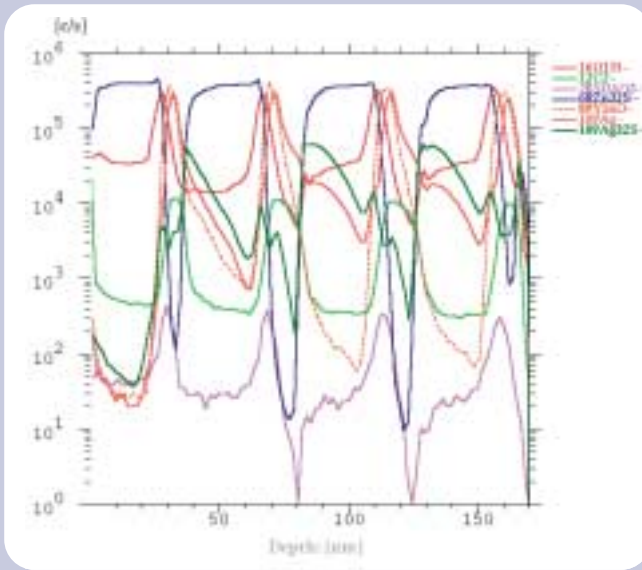
SIMS depth profile analysis of a non-defect area of the filter (left) clearly shows the alternating layer structure :-

- The individual layer thicknesses are ~10nm for silver and yttrium oxide layer and ~30nm for zinc sulphide.
- Formation of silver sulphide has occurred through chemical interaction between the adjacent silver and zinc sulphide layers.
- Carbon contamination is present at or near to the silver / zinc sulphide interfaces. This is probably a result of poor vacuum quality in a reactor vessel.

- OH is found in the zinc sulphide layer and particularly at the zinc sulphide / yttrium oxide interface. Again this may be indicative of poor vacuum quality during layer deposition, or moisture ingress post-production.

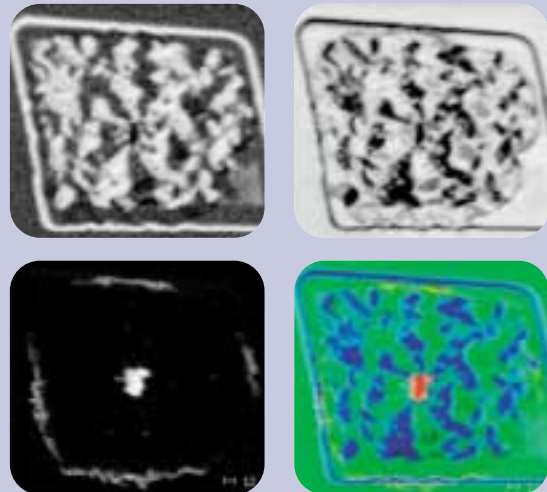
Progressive SIMS image acquisitions through a defect area (right) show the buckling and displacement of the layer structure and the probable cause of defect formation :-

- A silicate-rich particulate is found at the centre of the defect area at the interface between original glass substrate and the coating layer structure.
- Localised physical stresses in the coating, caused by the particulate and expansion of any associated moisture, result in the eventual distortion of the coating, radiating outwards from the nucleation site.

SIMS images of defect area showing yttrium oxide (YO_2^- - top left), zinc sulphide (ZnS^- - top right), silicate (SiO_3^- - bottom left) and overlaid (bottom right).

On CSMA's recommendations, based on this work, a more rigorous cleaning and inspection process for the glass substrates was implemented by the manufacturer, resulting in subsequent yield improvements.
